Debris/Ice/TPS Assessment and Integrated Photographic Analysis of Shuttle mission STS-112

**DEBRIS/ICE/TPS ASSESSMENT and
INTEGRATED PHOTOGRAPHIC ANALYSIS
OF SHUTTLE MISSION STS-112**

Armando Oliu
Process Engineering/Mechanical System Division/ET-SRB Branch,
Kennedy Space Center, Florida

October 7, 2002

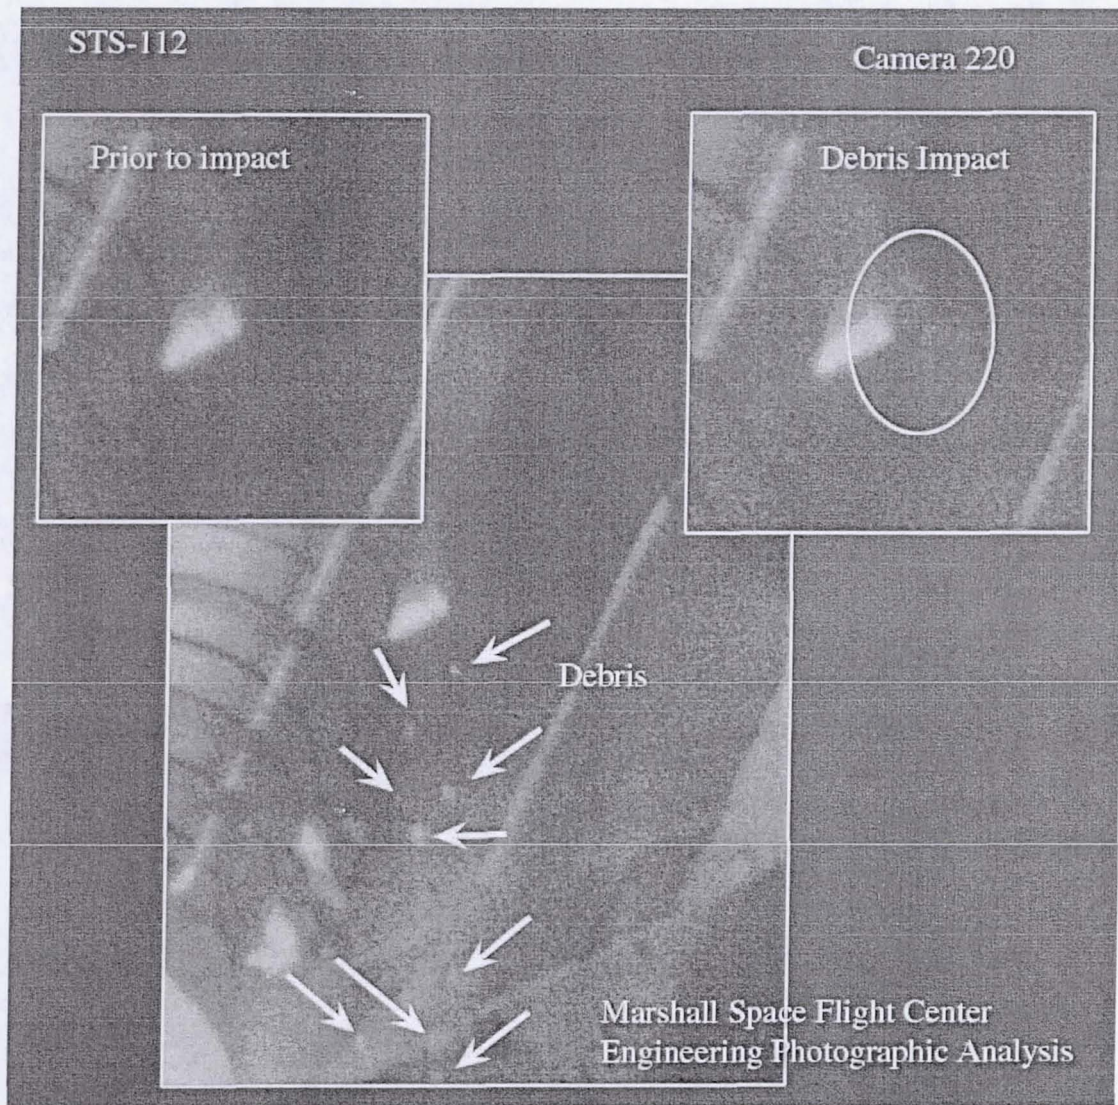
Figure 4. E220: Left SRB IEA Box Debris Impact Sequence

Numerous pieces of debris material are observed after impact with area near the left SRB IEA Box. Inserts illustrate the area prior to and during debris impact with the left SRB.

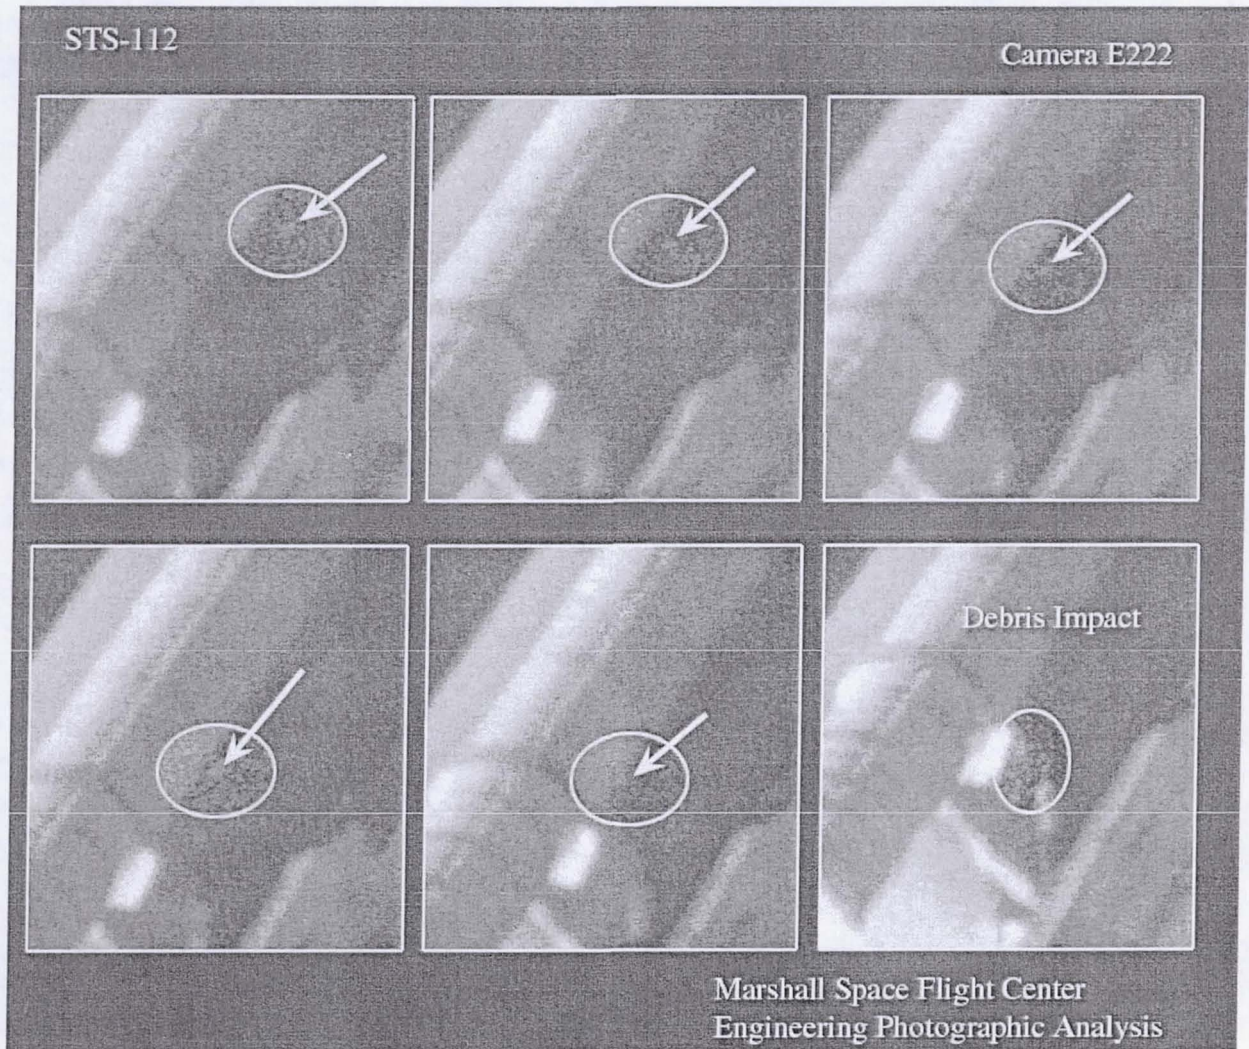
Figure 5. E222: Image Sequence of Debris Prior to Impact with IEA Box

The most significant event observed in the film review was as follows: at 19:46:24.610 UTC (approx. T+33 seconds) a particle was observed traveling along side the ET LH2 tank and impacts the forward face of LH SRB IEA generating a shower of particles aft of IEA. No impact with the orbiter was observed. (E-212, E-220, E-222)

Close-up images that clearly show the debris falling aft toward the Left SRB and finally impacting the IEA Box area. The arrows in the enhanced circular areas of each frame indicate the location of the debris.

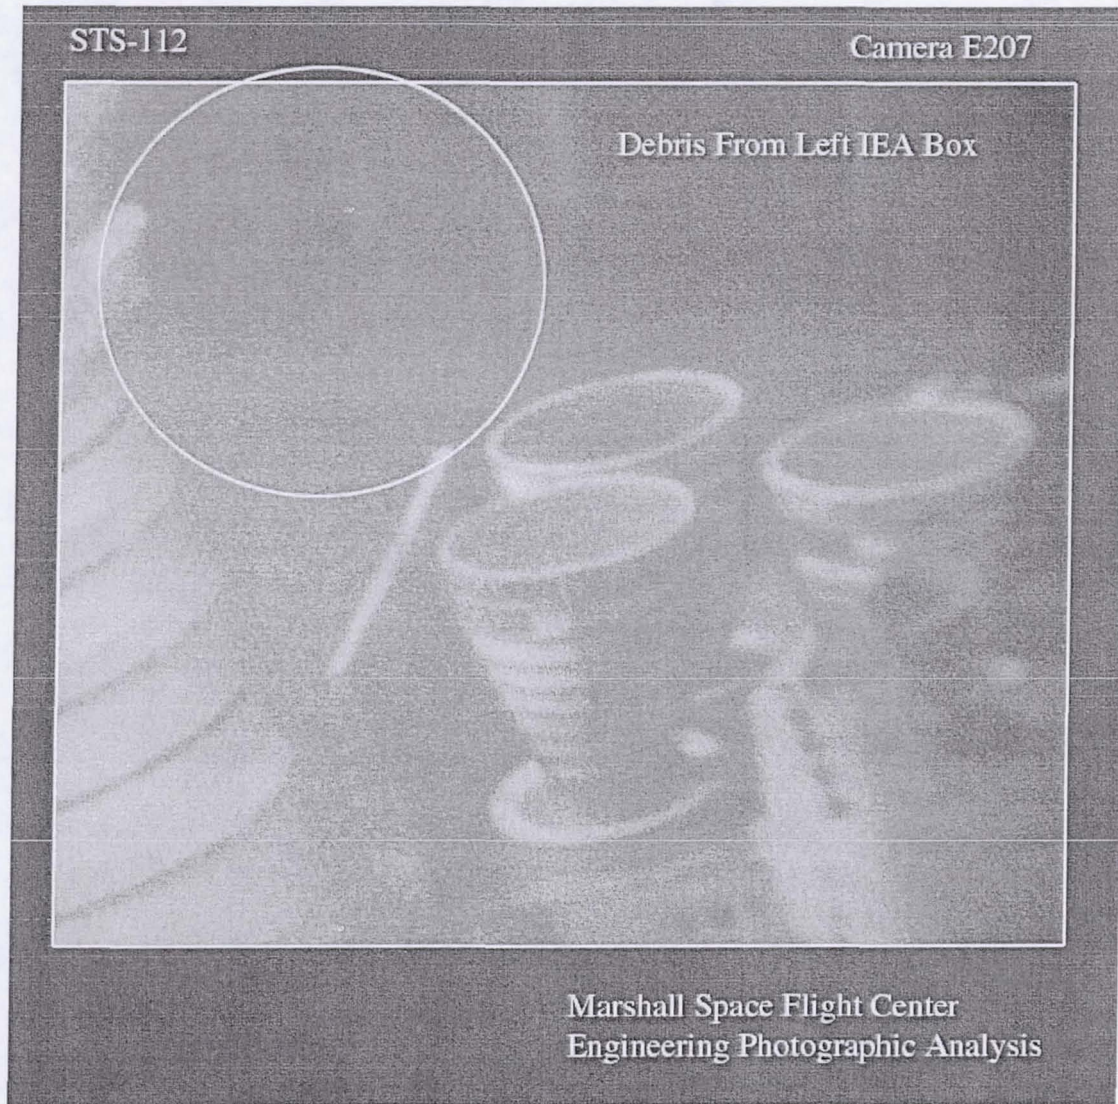
Figure 6. E207: Debris Scatter from Left SRB IEA Box Impact

Although the Left SRB IEA Box was not imaged by film camera E207 at the time of impact, a spray of debris material was noted falling aft.

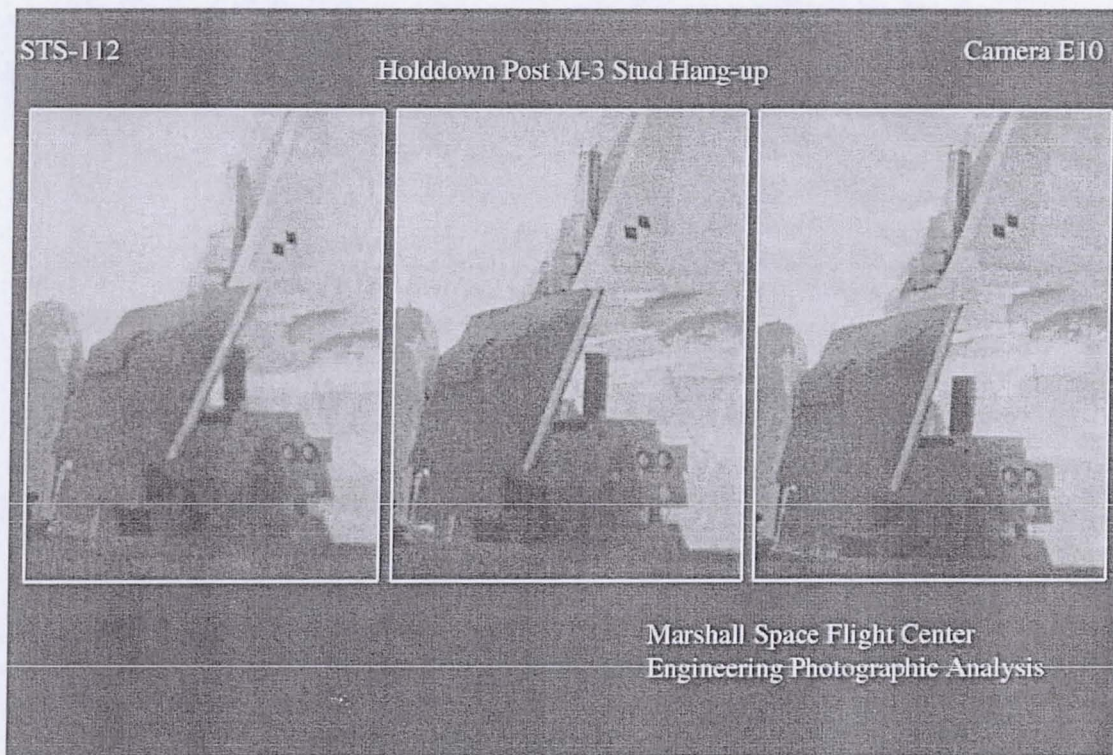
Figure 7. E010: Holddown Post M-3 Stud Hang-up

As expected, broaching occurred in the holddown stud bore of post #3 consistent with stud hang-up seen in the post launch film review. Minor thread marks from the holddown studs could be seen on all of the remaining stud bores.

The RSRB Holddown Post M-3 Bolt was seen to hang up during liftoff. Stud hang-ups have occurred on previous missions. This event was imaged at 280:19:45:51.611 UTC.

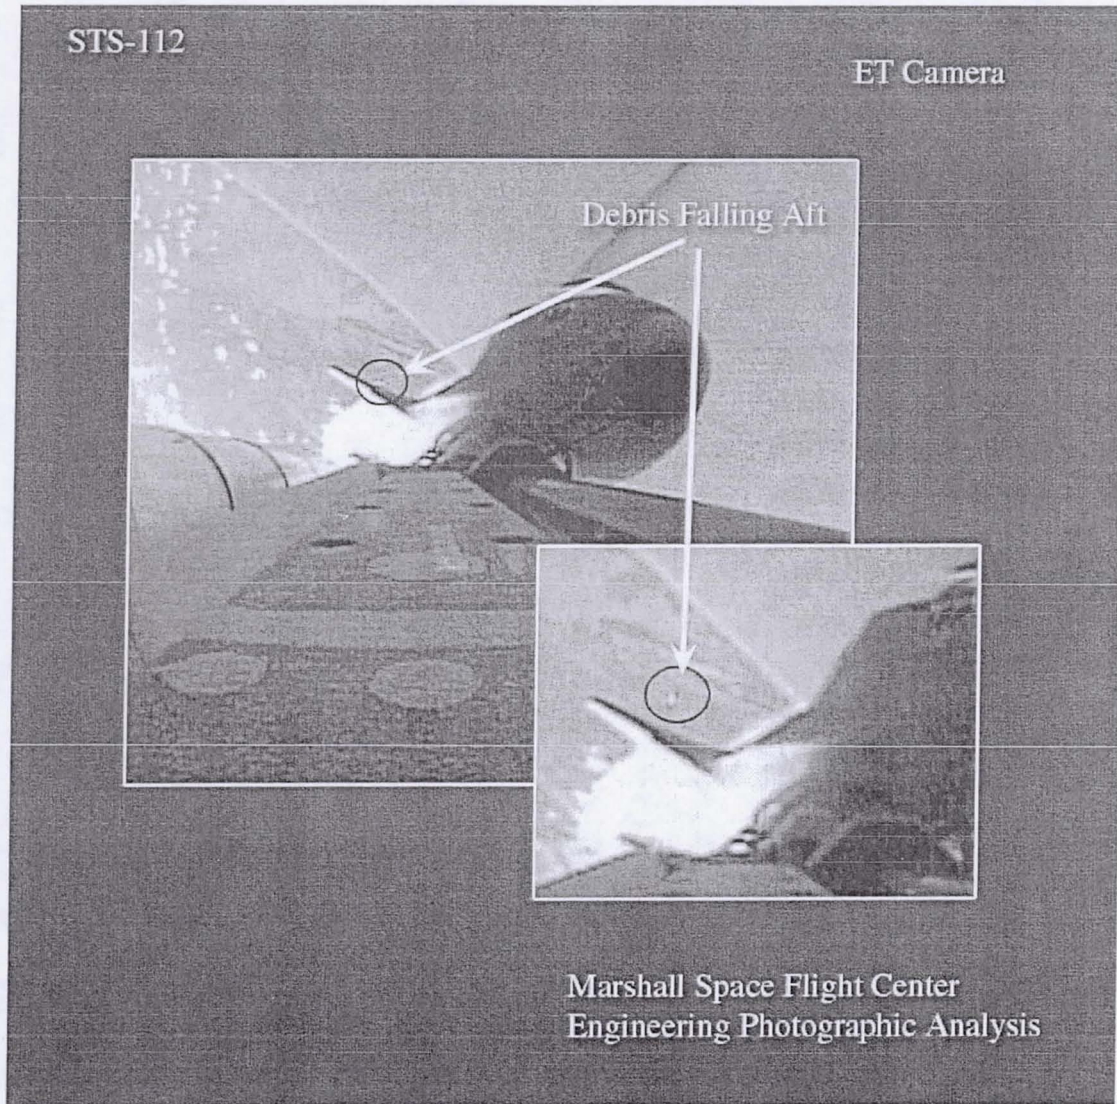
Figure 8. ETCAM: Debris Seen Over Right Wing Falling Aft

Debris was noted falling aft during ascent. The debris appears over the right Orbiter wing, but it is uncertain as to whether the debris is near the Orbiter wing.

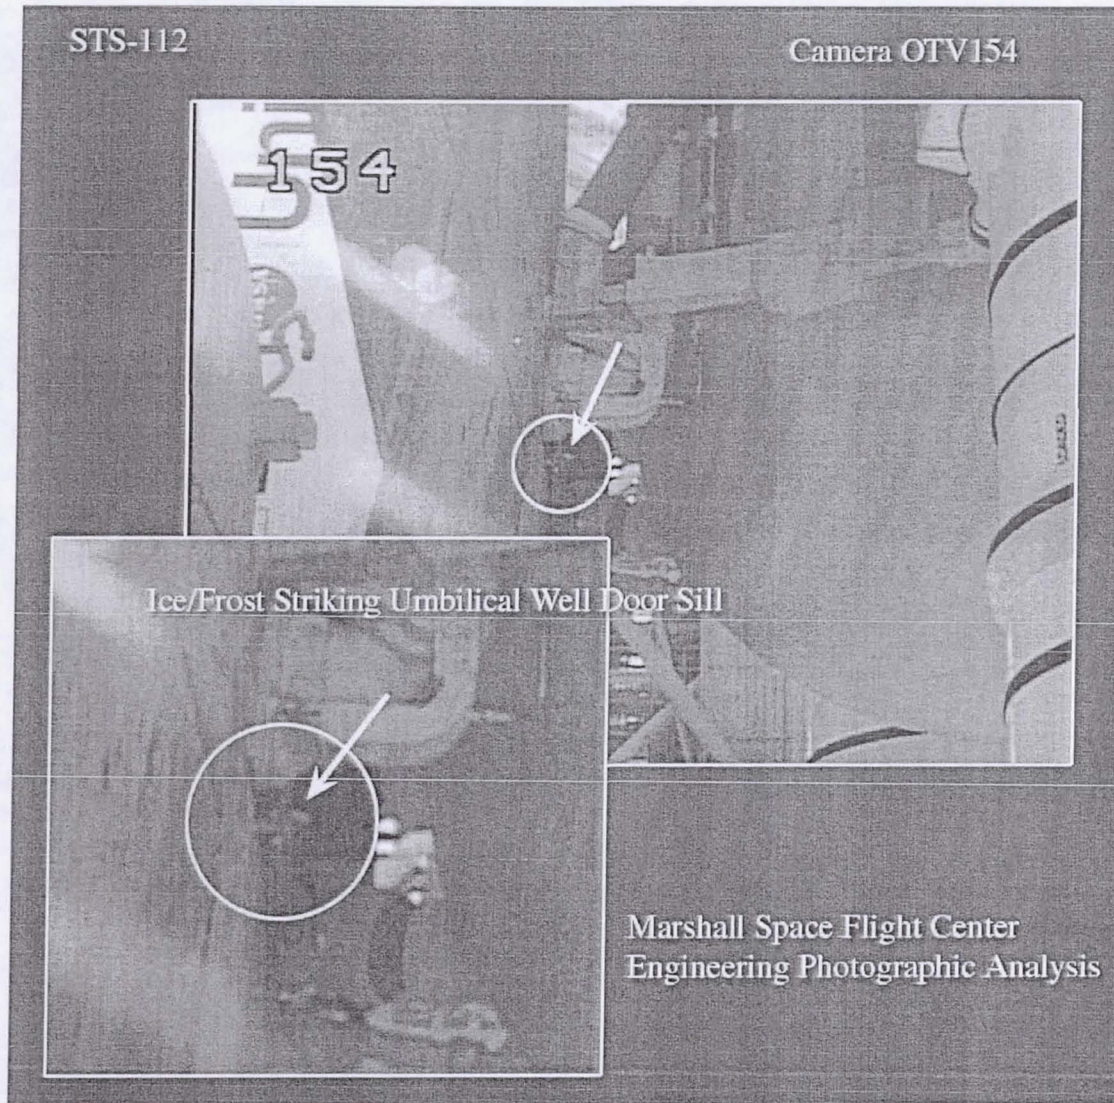
Figure 16. OTV154: Ice/Frost Striking Umbilical Well Door Sill

Ice/frost was observed striking the LO2 Umbilical Well Door Sill. No damage to the vehicle was noted. This is a common observation.

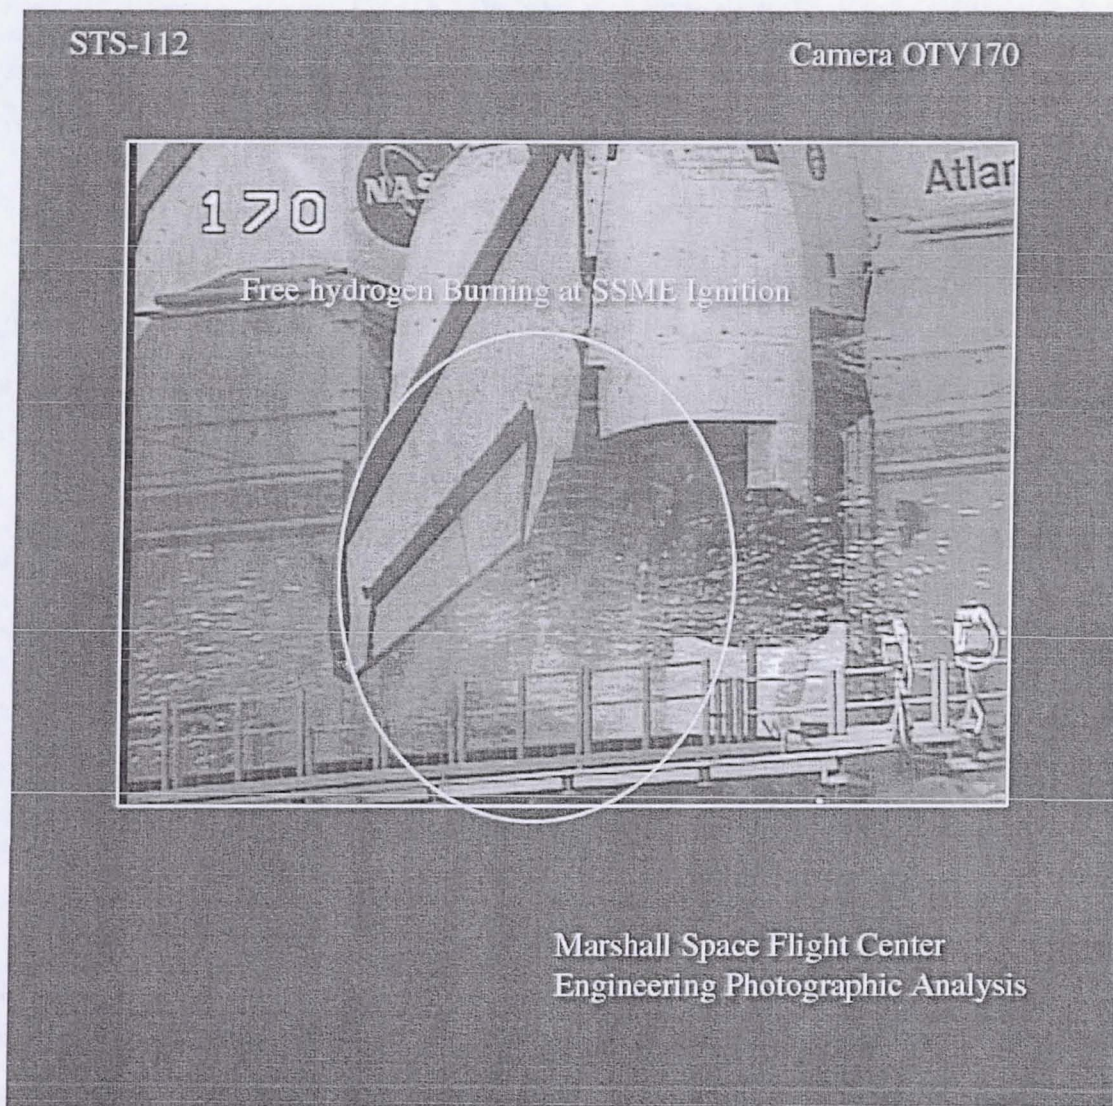
Figure 18. OTV170: Free Burning Hydrogen

An orange-colored vapor was noted near vertical stabilizer at SSME ignition. This is a typical observation and is assumed to be an indicator of free burning Hydrogen.

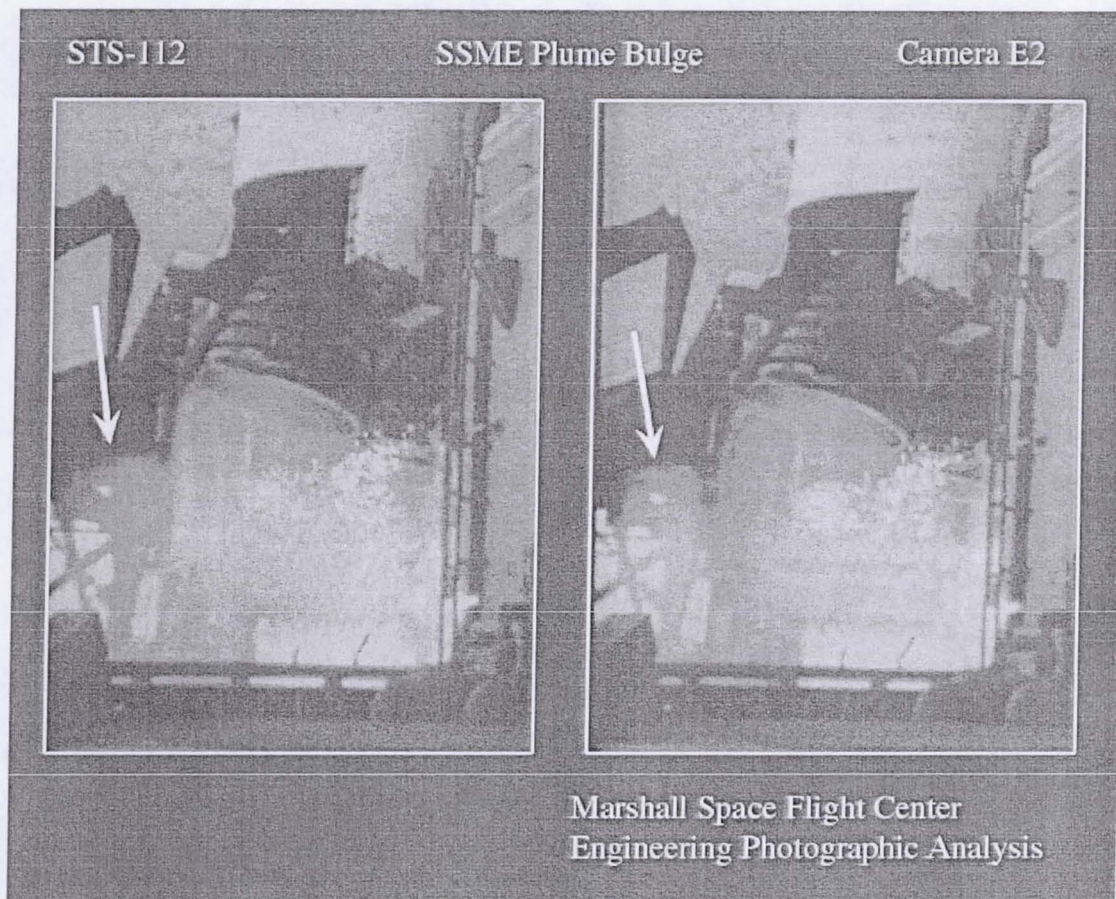
Figure 19. E002: Late Occurring SSME Plume Bulge

A bulge in SSME#1 plume was observed, beginning at 280:19:45:47.611 UTC, or approximately 2.9 seconds after SSME#1 start time (280:19:45:44.694 UTC). This is similar to the bulge noted in SSME#1 plume on missions STS-111 and STS-110.

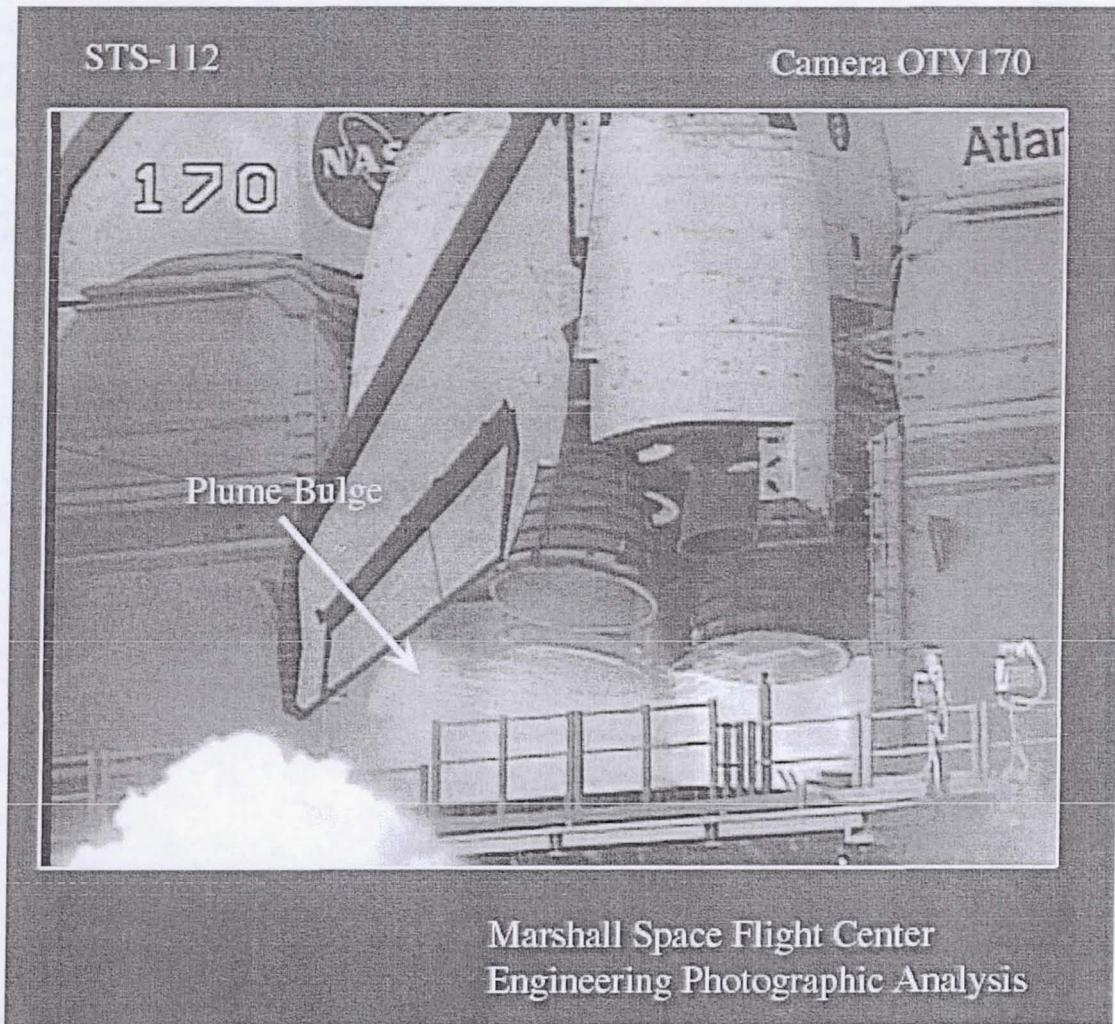
Figure 20. OTV170: Late Occurring SSME Plume Bulge

A view of an SSME#1 plume bulge from video camera OTV170. This is the same plume bulge noted and imaged from film camera E002.

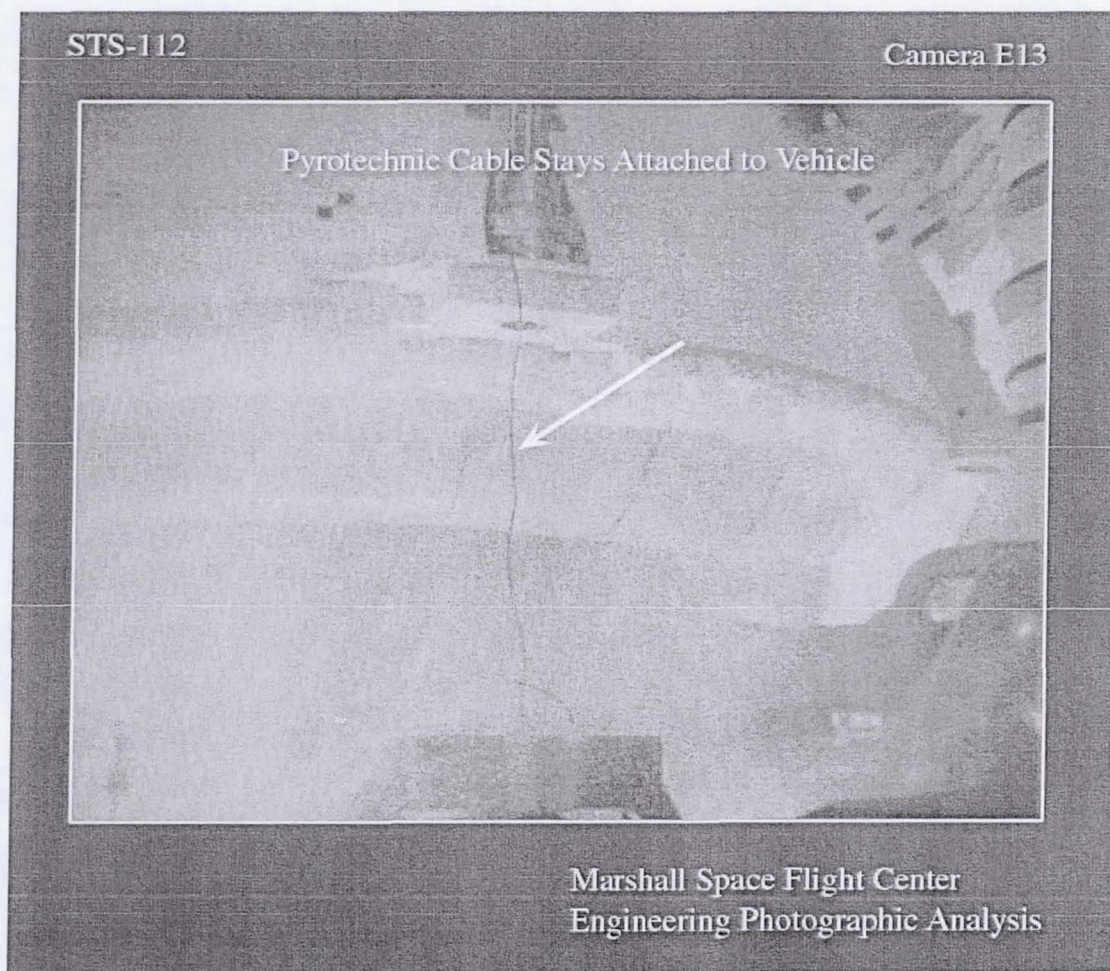
Figure 26. E013: Pyrotechnic Cable Stays Attached to Vehicle

It was learned that during STS-112 launch, the "A Circuit" on the Left SRB failed to initiate firing. This failure would aid in preventing the explosive from severing the left (A side) Pyrotechnic Cable and as a result, the cable would likely remain attached until snapped by separation of the HDP from the booster. It was also noted that the left (A side) cable on other HDP's was stretched further than the cable on the right before being snapped.

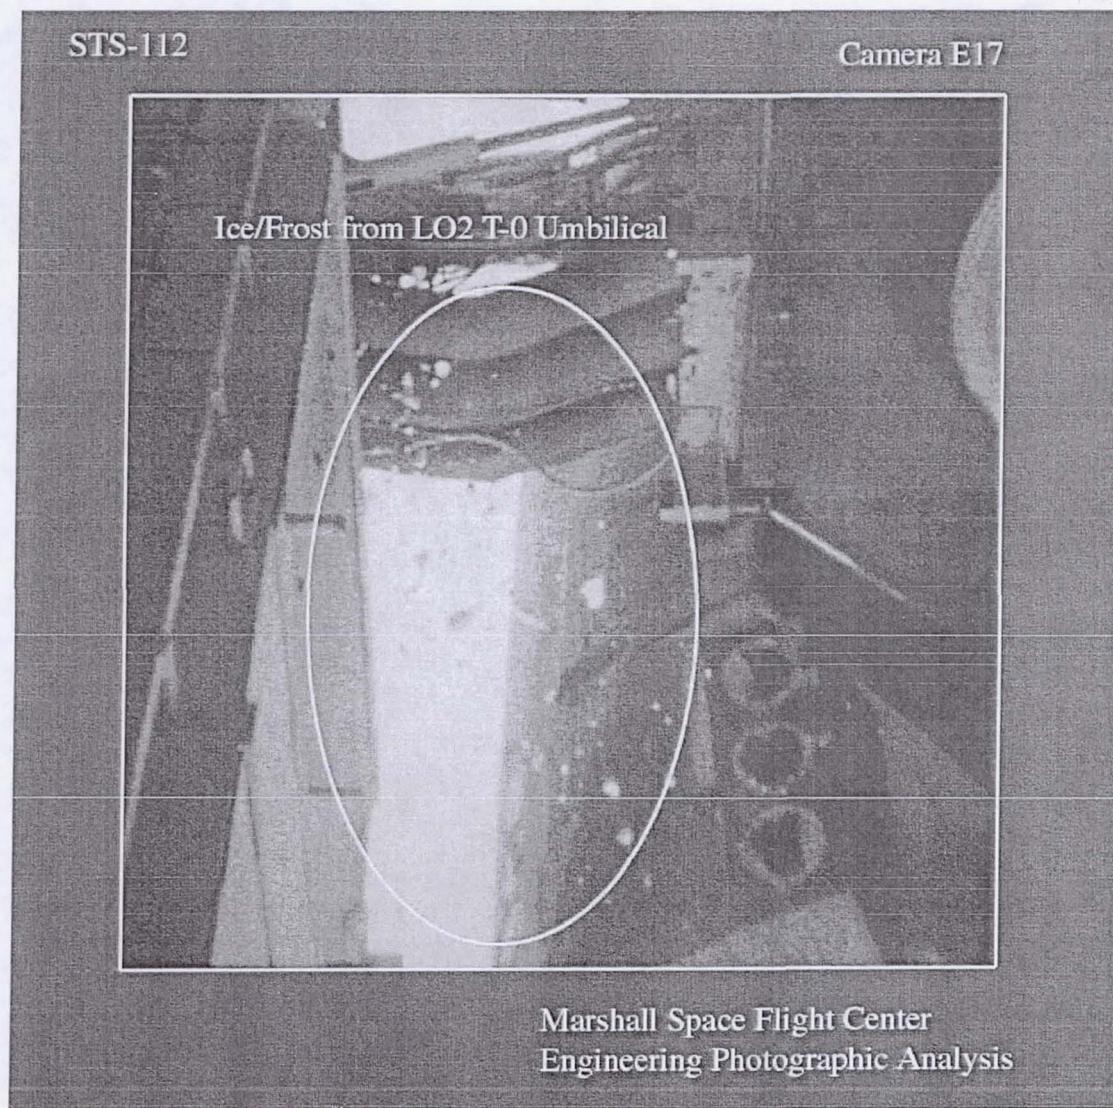
Figure 28. E017: Ice/Frost from LO2 T-0 Umbilical

A notable amount of ice/frost fell from the LO2 T-0 Umbilical. Ice/frost falling from the LO2 T-0 Umbilical is a common event.

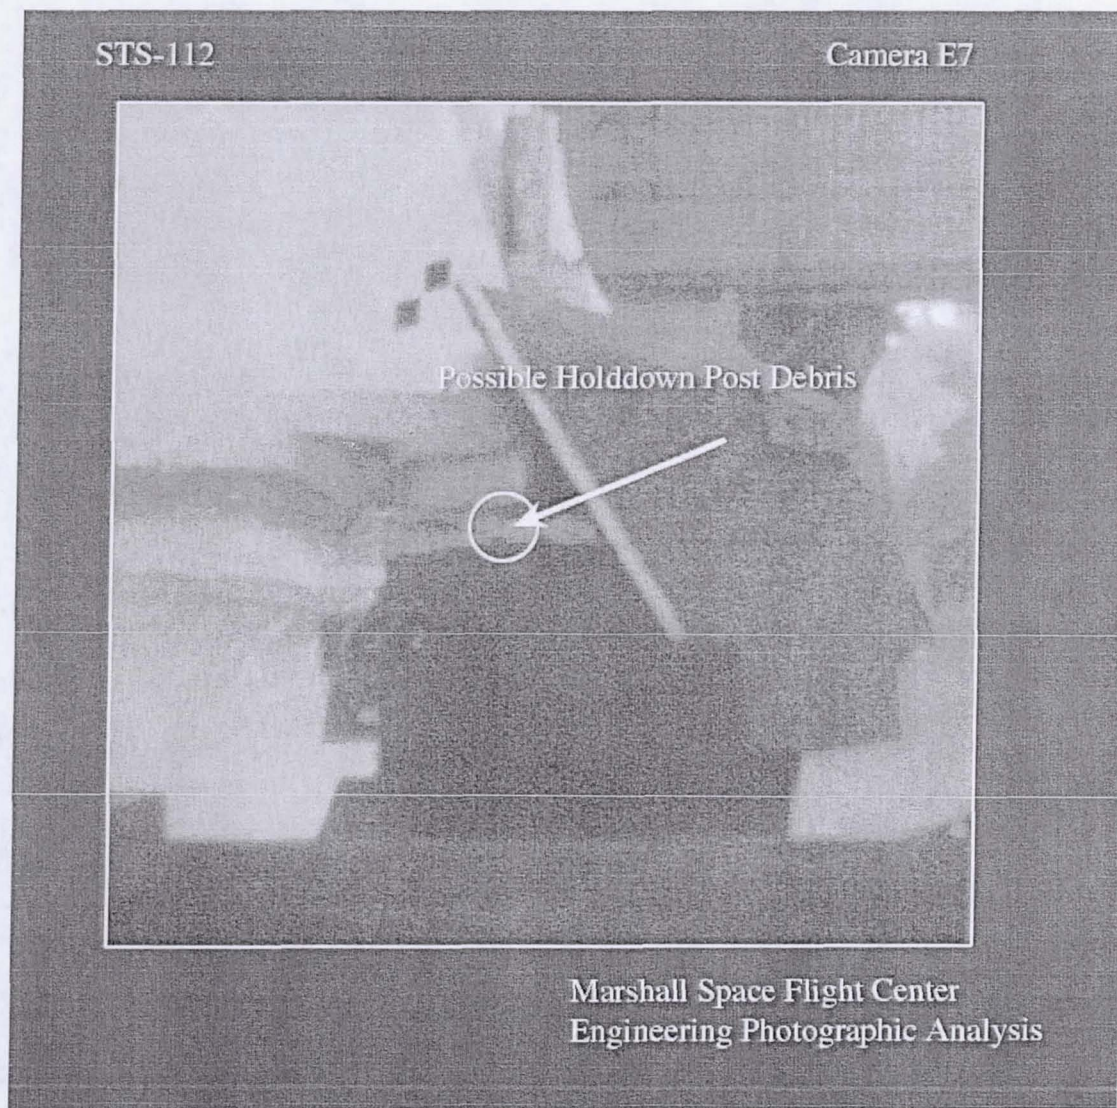
Figure 31. E007: Possible Debris from Holddown Post Hole M4

Debris was noted above HDP M-4 shoe. A possible source of this debris was from the Holddown Post Hole.

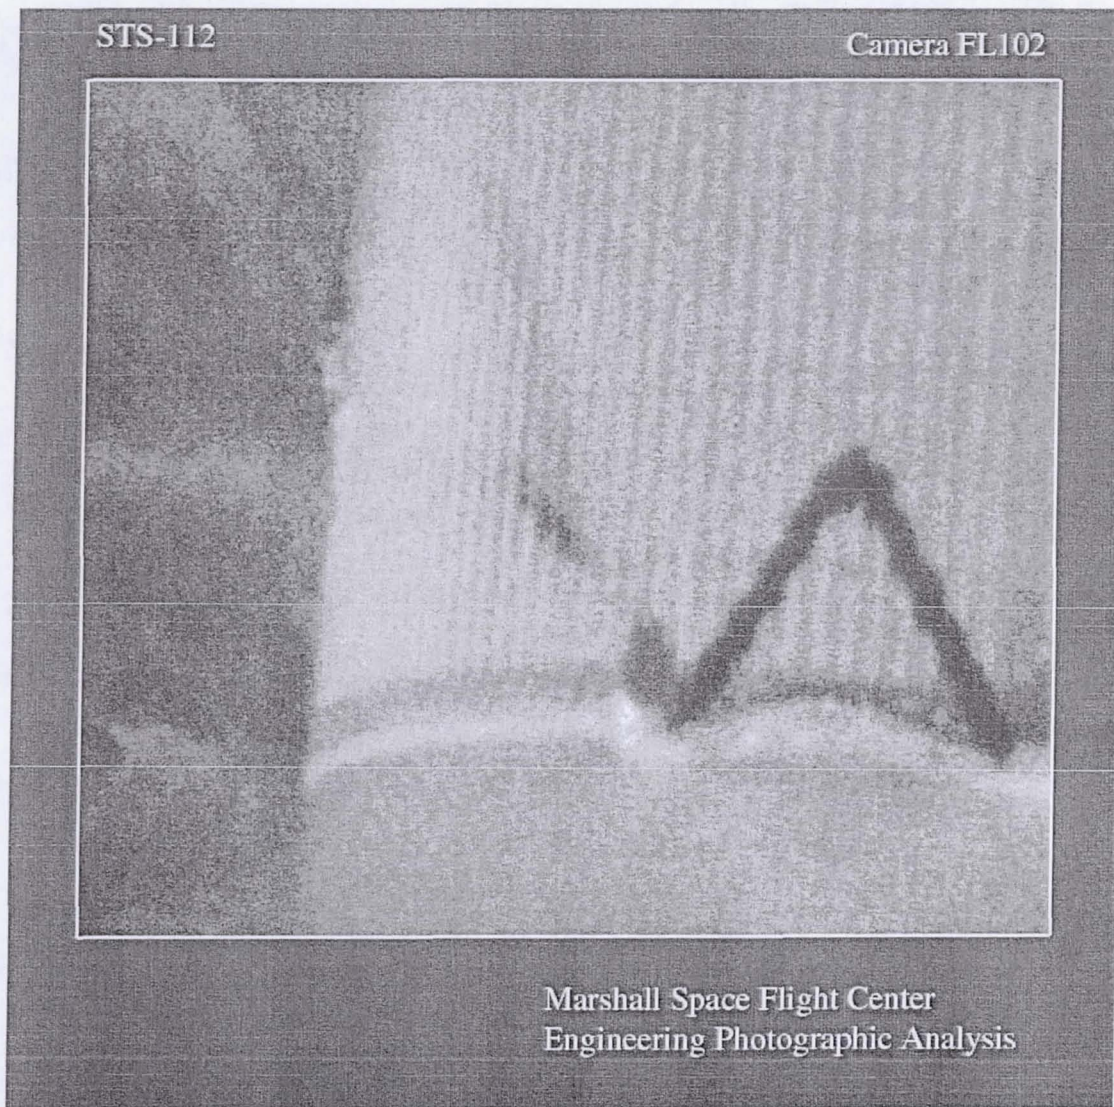
Figure 32. FL102: View showing -Y Thrust Panel TPS loss

Small "popcorn" divots were observed on the -Y thrust panel aft of the ET/SRB attach point in the non-vented area.

Divots may be observed in the TPS on the -Y Thrust Panel, but the loss appears to be in an unvented region and is considered normal. The large divot on the foot of the bipod, as well as two divots under the bipod, are also visible.
